TECHNICAL CIRCULAR No. 025 of 16 August 2011

To:	All Surveyors
Applicable to flag:	All Flags
Subject:	Rudder and Rudder Posts/Horn Defects
Reference:	CLASS-Dry-dock survey-Rudder

RUDDER AND RUDDER POSTS / HORN DEFECTS

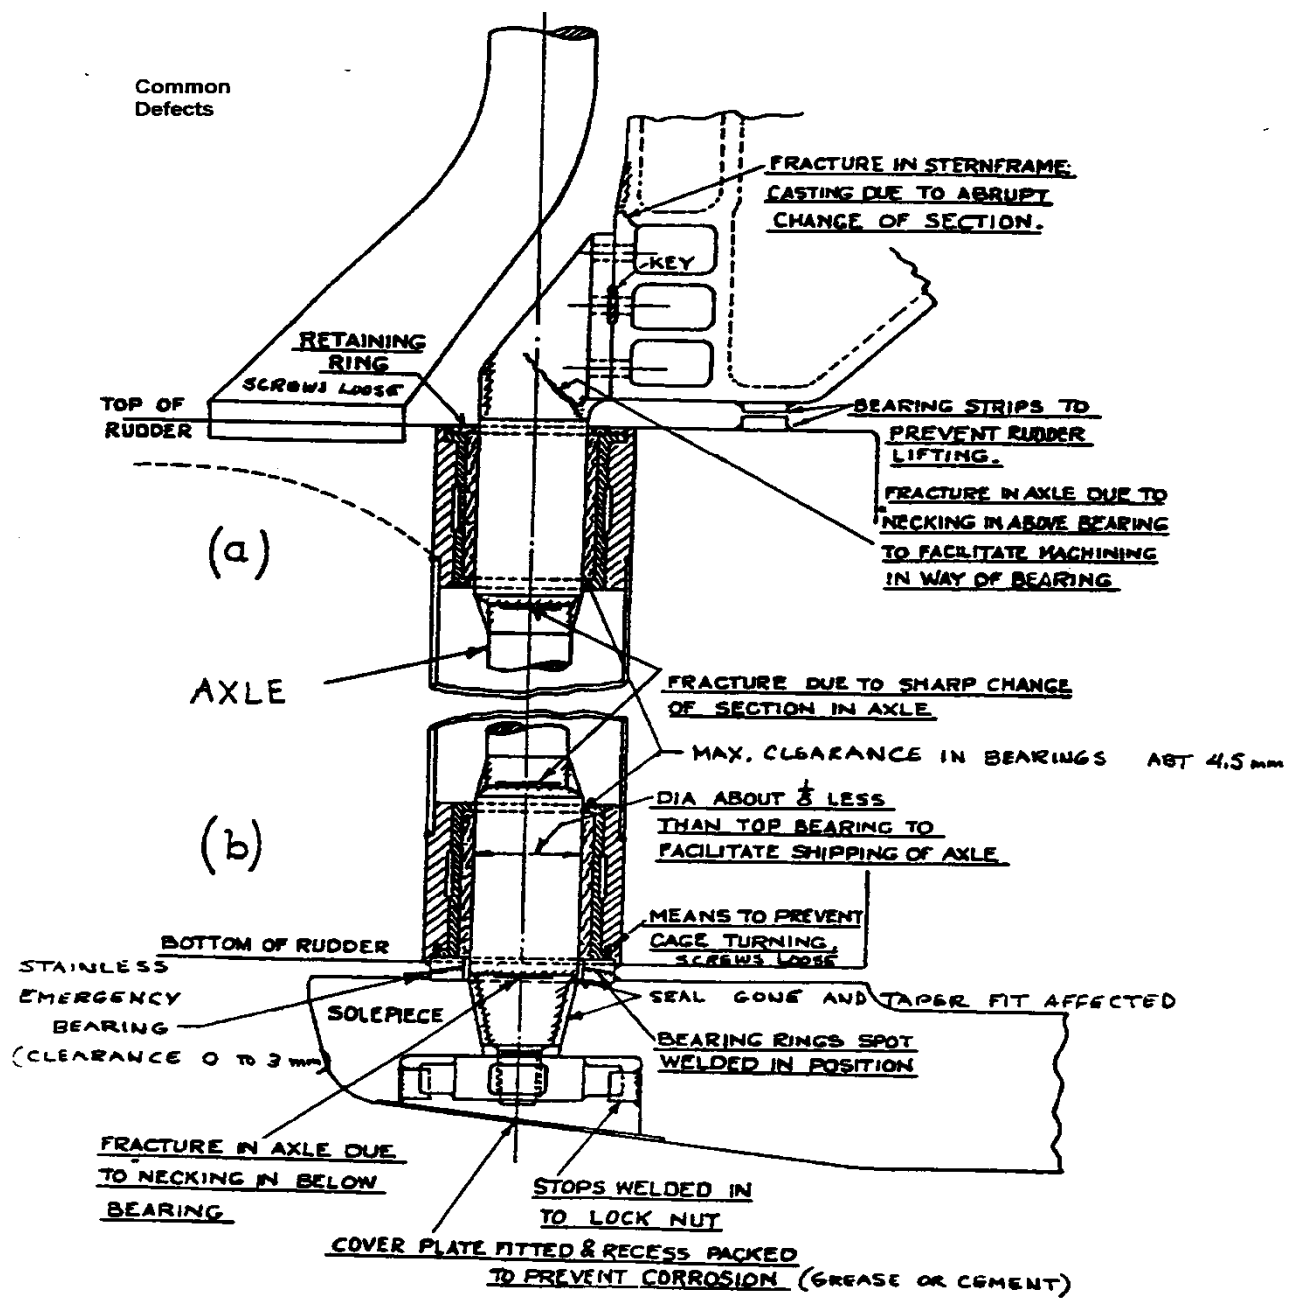
Fig. 1 Potential Rudder damages

Fractures at sharp change of section on underside or rudder axle palm (top), also at top of taper on lower end of rudder axle.

Rudder load being carried by conical-faced "emergency" bearing on lower end of rudder (to shoe piece). (Actually, there should be a slight clearance [1 to 3 mm] at this bearing under drydocking conditions with after peak tank empty).

Excessive wastage of rudder axle adjacent to the bronze sleeves. This normally should be dealt with by cleaning, wire brushing, painting or epoxy coating. Weld build-up of the axle forging is not recommended, unless the excessive wastage extends over at least 25% the area surface, and then only with proper approved procedure and heat treatment.

Excessive wastage on rudder axle lower-end taper or of the axle between the bottom taper and the lower bronze sleeve. The latter should be protected with paint or epoxy coating. The taper may need to be re-machined however, to ensure tightness of the axle in the seating.

Insufficient locking arrangements or slack nut on rudder axle lower end securing.

Loose or fractured palm bolts at upper end.

"Notches" or stress raisers at top or bottom of rudder axle. These should be smoothed out as possible.

Excessive clearances of rudder axle in rudder bearings (4.5 mm maximum recommended).

Gudgeon retaining rings (for the lignum-vitae staves) not properly secured.

With axle tight in lower taper (in shoe piece), palm at upper end of axle should bolt up without any "springing" or forcing to line-up holes.

Deutsche Werft "SIMPLEX" Type Rudder
