TECHNICAL CIRCULAR No. 305 of 16th November 2015

To:	All Surveyors/Auditors
Applicable to flag:	All Flags
Subject:	<b>Cargo hold region –Upper structure inspection</b>
Reference:	<b>Structural detail failure and repairs</b>

**Structural detail failure and repairs**

**What to look for – Internal inspection**

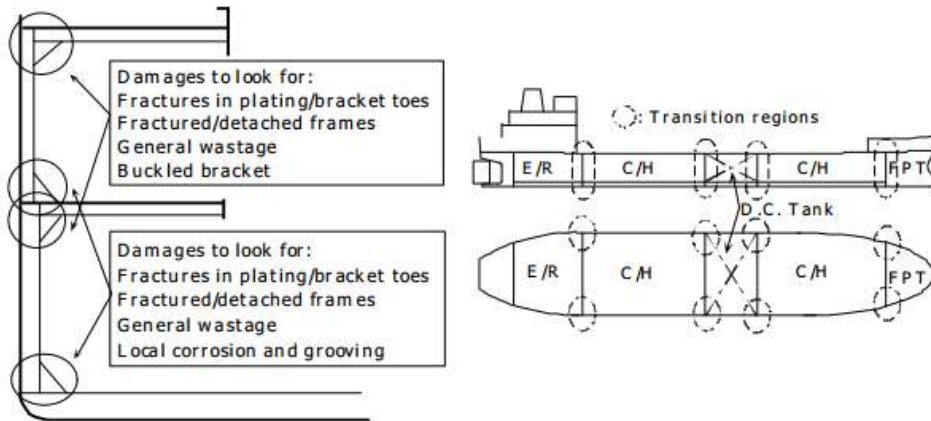
Figure 1 Potential problems areas

1.5 The transition regions are subject to stress concentrations due to structural discontinuities. The side shell plating in fore and aft transition regions is also subject to panting. The lack of continuity of the longitudinal structure, and the greater slenderness and flexibility of the side structure near the more rigid end structures, can result in damages.

1.6 A summary of potential problem areas is shown in Figures 1 (a) and (b).

(a) Side shell frames

(b) Transition regions
