## TECHNICAL CIRCULAR No. 322 of 10<sup>th</sup> February 2016

To:	All Surveyors/Auditors
Applicable to flag:	All Flags
Subject:	Salt Limits to Prevent Premature Coating Failures
Reference:	Drydock and Special Survey

## Salt Limits to Prevent Premature Coating Failures

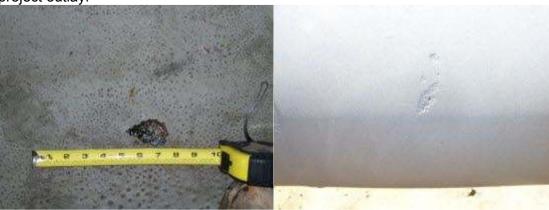
### Salt-induced pitting before and after surface cleaning (not the same location).

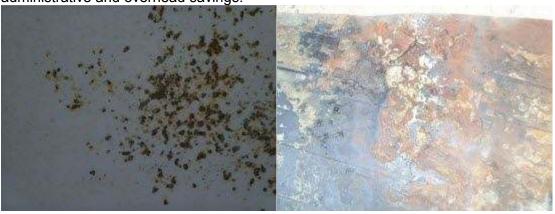
### Tank salt-induced coating failures.
